# **4EAT TRANSMISSION DIAGNOSIS - PART II**

**Video Reference Booklet**

**TECHNICAL TRAINING**

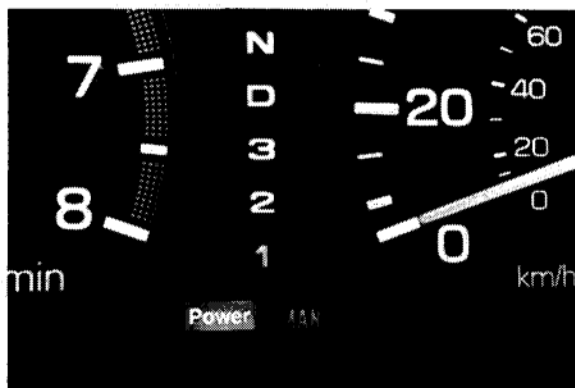
*Power Light "Flashing"*

In this case, when the "Power Light" flashes 16 times upon start up, this is a clue that an electrical problem is indicated and it is most likely the cause.

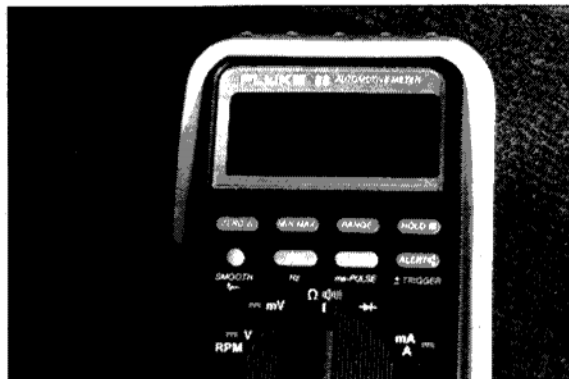
**Ohm Meter: Infinity ("O.L")**

An ohm meter reading of infinity indicates that the wire is "OPEN" between the TCU and the Solenoid.

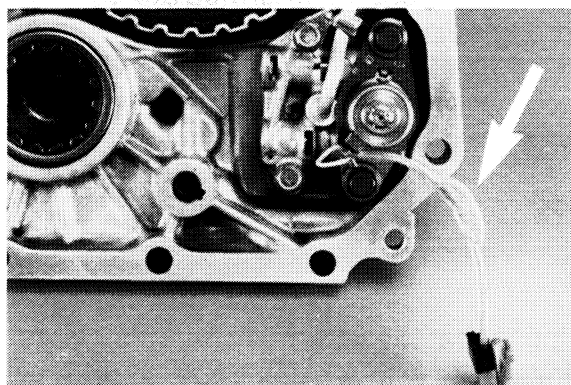
***Damaged Solenoid "C" Wire***

When the rear housing was removed, we found a damaged wire. It may have been pinched during the previous repair.

After making a repair, verify the fix by again back probing the white wire with the black tracer at the TCU connector.

At this point, proper duty solenoid resistance indicates that the problem is repaired.

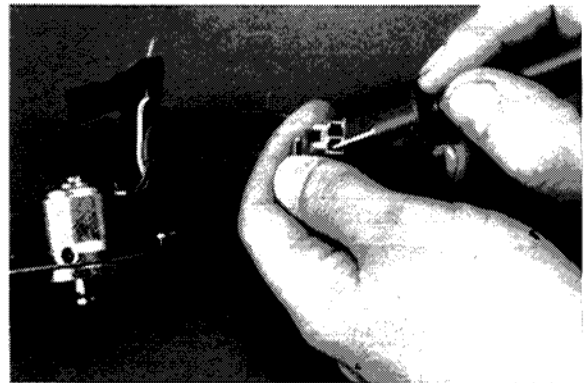
*Solenoid "C"*

We attempted to activate the solenoid by applying battery voltage with a pair of test leads. Since we didn't hear a click we knew that the solenoid was mechanically inoperative, so we replaced the solenoid.

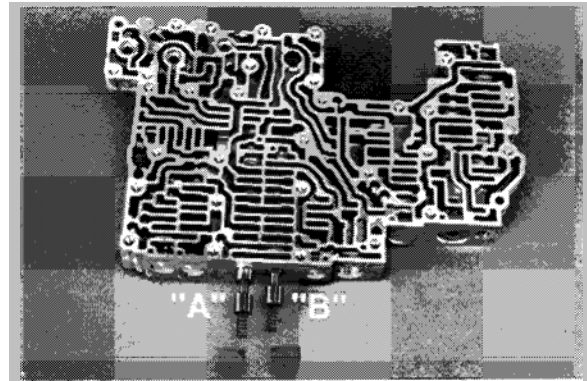
***Shift Valves "A" & "B"***

As we examine the valve body, however, we first find evidence of contamination and then find that shift valves "A" and "B" are binding in their bores.

At this point, we thoroughly cleaned and inspected all of the valve body components. We also flushed the transmission cooler. We then reassembled and installed the valve body as described in the Subaru Service Manual, section 3-2.

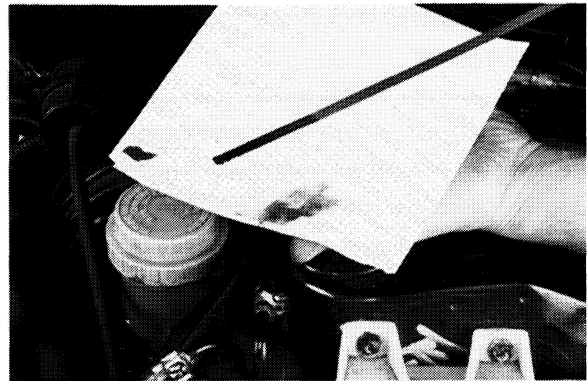
***Transmission Fluid Dipstick***

A check of the transmission fluid shows that it is discolored and smells burnt. At this point, there is no doubt that the transmission has an internal mechanical problem.

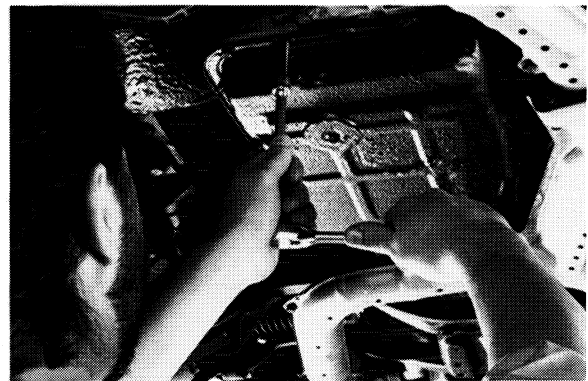
***Removing Pan***

When the transmission pan was removed, we found a large amount of metal contamination confirming our suspicions.

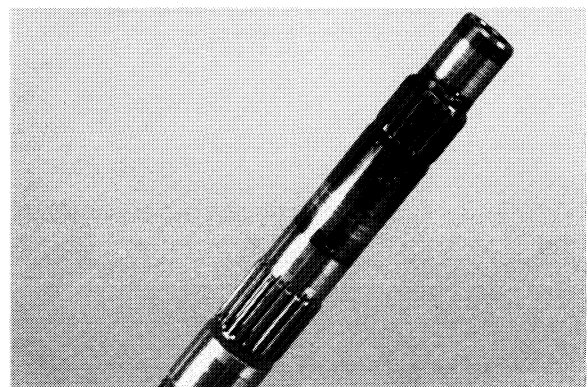
***Discolored Input Shaft***

During the disassembly we noticed that the input shaft was blue in color back at the sun gear splines. This was the first indication of the source of our noise.

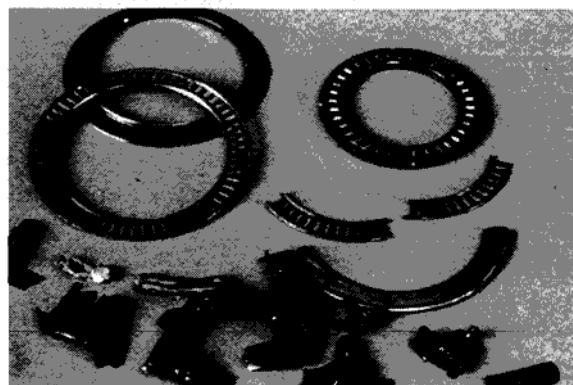
***Damaged Bearings/Thrust Washers***

In addition, the needle bearings were damaged and the selective plastic thrust washers were melted. This was the cause of the noise and shifting problem.
