## Fuel System Fuel Trim

**F**uel trim refers to the PCM's ability to add or subtract fuel in response to changing engine operating conditions.

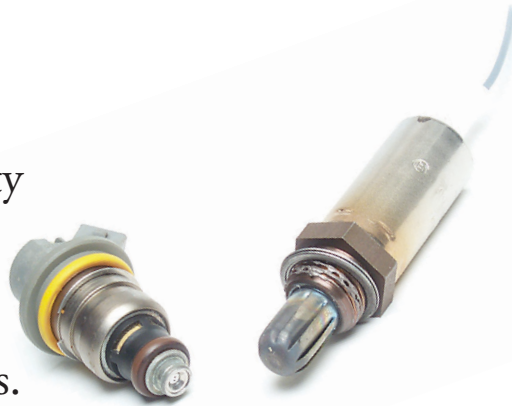
Perhaps you are familiar with what a conventional oxygen sensor waveform looks like. The oscilloscope trace repeatedly travels upward to a peak then downward to a valley, as the oxygen sensor reports the amount of oxygen present in the engine's exhaust. The peaks indicate a rich air-fuel ratio (high oxygen sensor voltage and low oxygen content), while the valleys indicate a lean air-fuel ratio (low oxygen sensor voltage and high oxygen content). When the oxygen sensor reports a rich mixture, the fuel system powertrain control module (PCM) responds by commanding a lean mixture. And when the oxygen sensor reports a lean mixture, the PCM responds by commanding a rich mixture. This is classic "closed loop" fuel control, with the PCM always a step behind in its response to the rich or lean voltage signal from the oxygen sensor.
